Alternative Technologies LLC

**Re. Asbestos Good Faith Inspection - Addendum 1 - AET # 3007.04 -Verification Inspection & Sampling
Hal Moe Pool - 403 Third Street, Snohomish, WA 98290-2571**

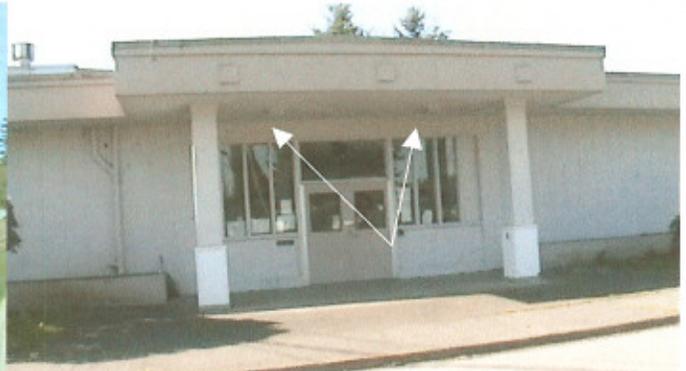
2. Sample # 33, Main Entrance Cement Asbestos board.

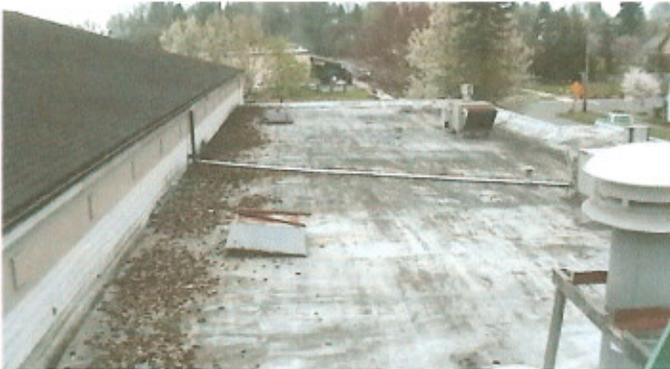
3. Looking West at NW flat roof from north central roof.

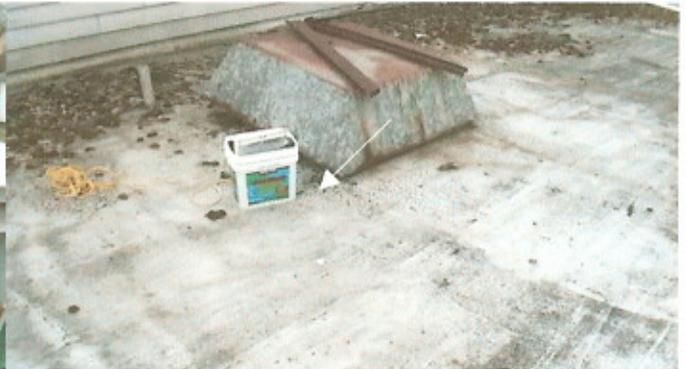
4. Spl: #2: Asbestos Silver Paint on non-asbestos built up.

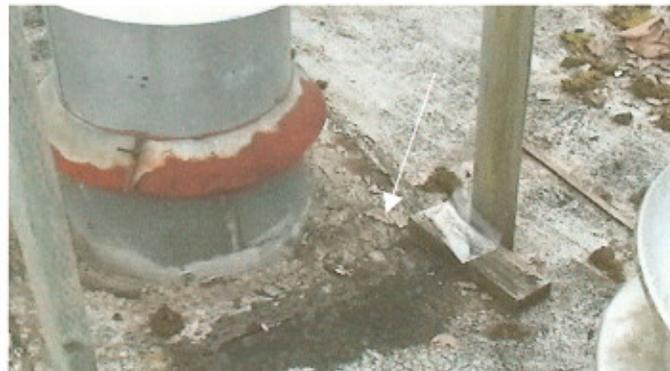
5. Sample #4: Asbestos Silver Paint on roof vent patch.

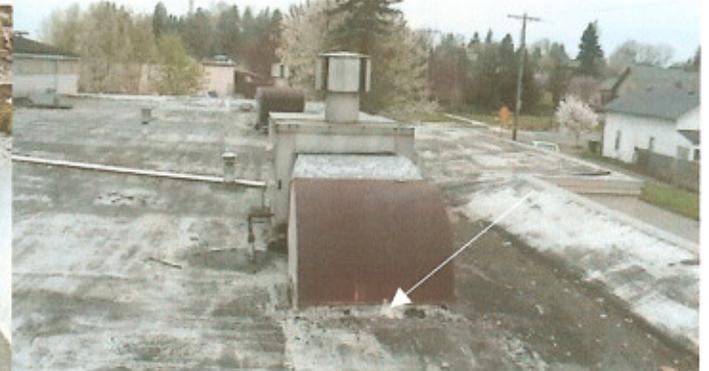
6. NW flat roof, HVAC unit, sample #5 location.

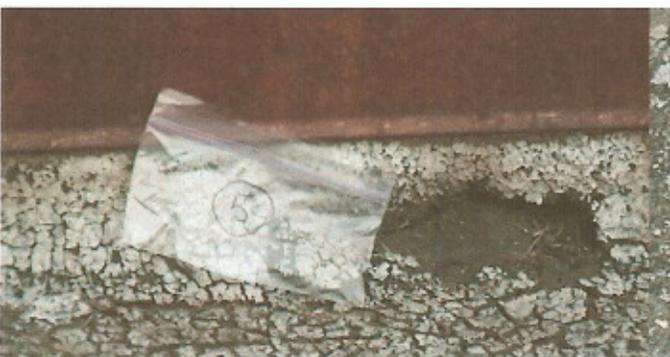
7. Sample #5: Asbestos Silver Paint.

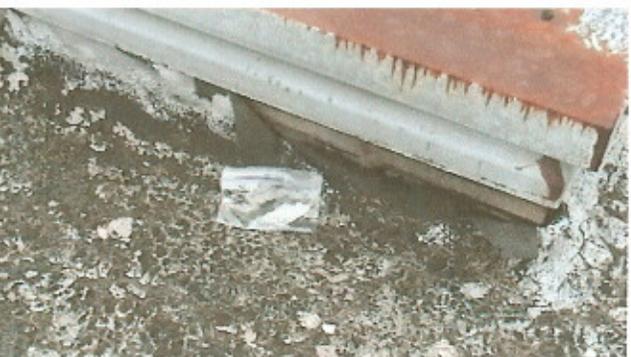
8. Sample #6: Asbestos Silver Paint

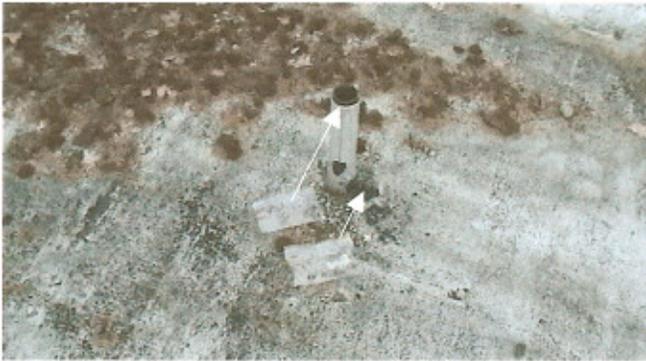
9. Spl. # 3L: Lead sheath on vent pipe, Spl. #8: Silver Paint

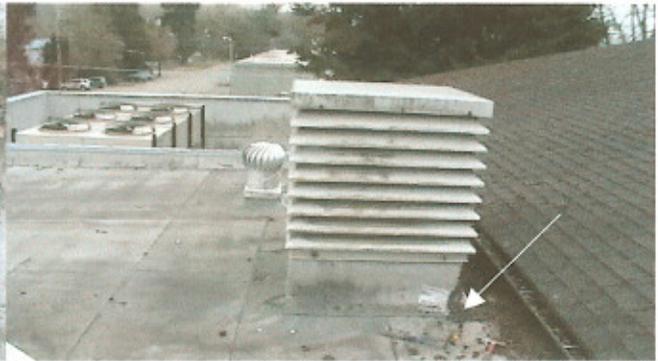
10. North Central flat roof Spl. # 9 location.

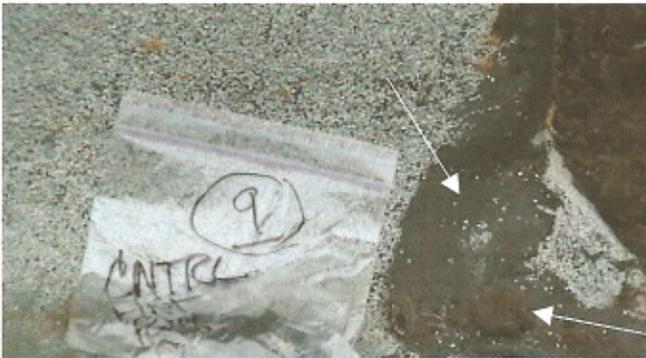
11. Sample # 9: Black asphaltic patch material.

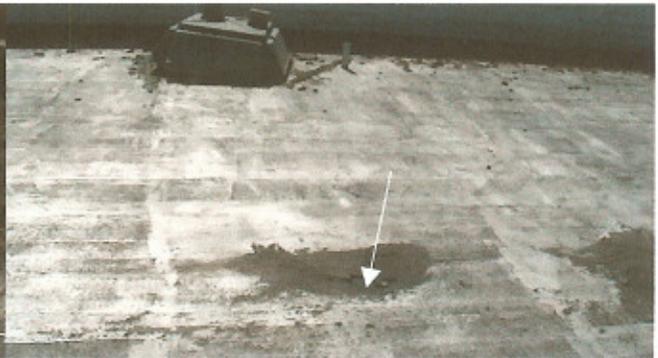
12. Sample # 34: Asbestos Silver Paint under patch.

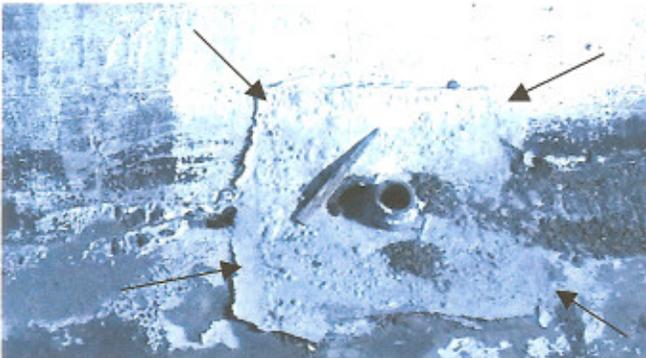
13. Sample # 38: 18" square, drain-patch (3 locations)

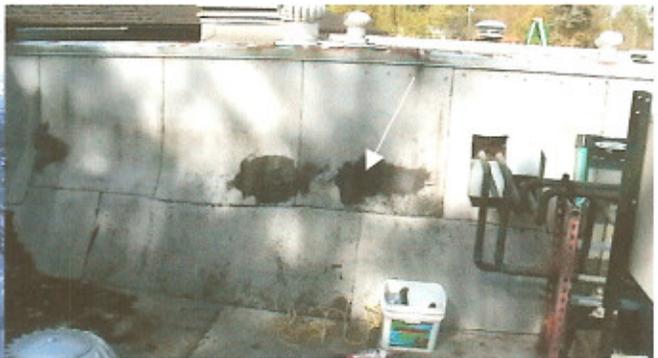
14. Sample # 40. Black asbestos wet patch. Typical

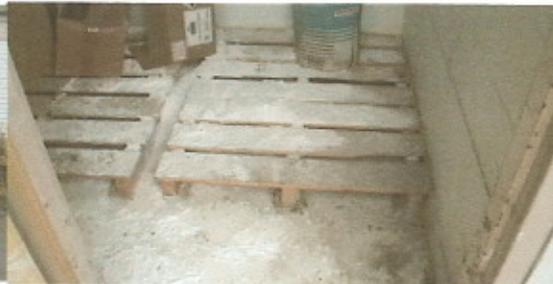
2. Sample #1: White powder on pallet and floor.

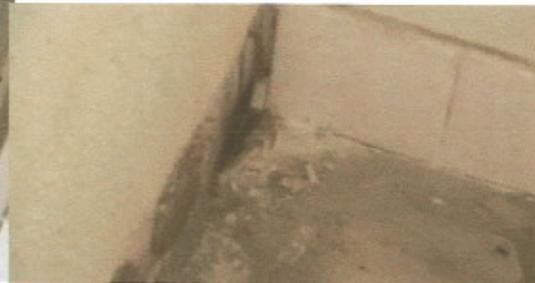
3. Sample #2: Ceramic cove base & mastic

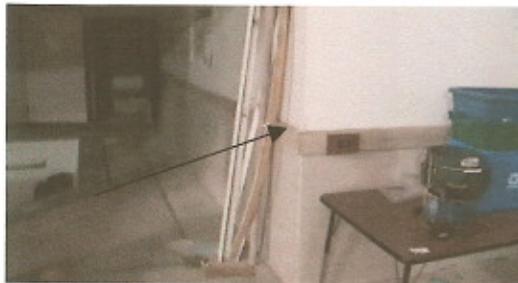
4. Sample #3: Gypsum wallboard

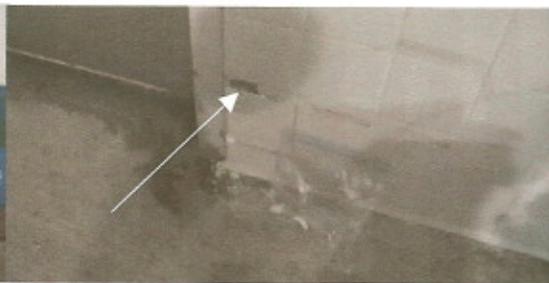
5. Sample #4: Ceramic cove base tile and mastic.
