# Alternative Technologies LLC

**Re. Asbestos Good Faith Inspection - AET Project No. 2968**  
Hal Moe Pool, 403 Third Street, Snohomish, WA 98290-2571

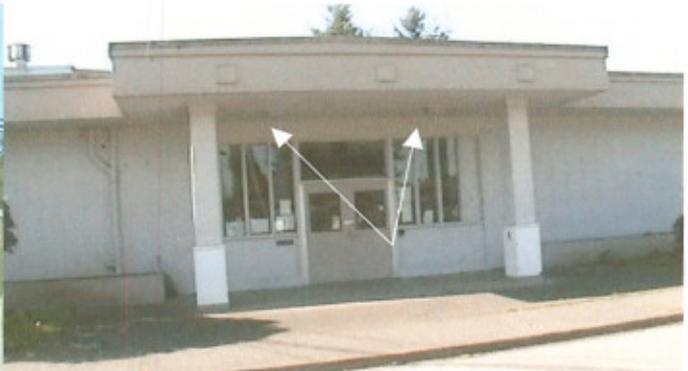
2. Sample # 33, Main Entrance Cement Asbestos board.

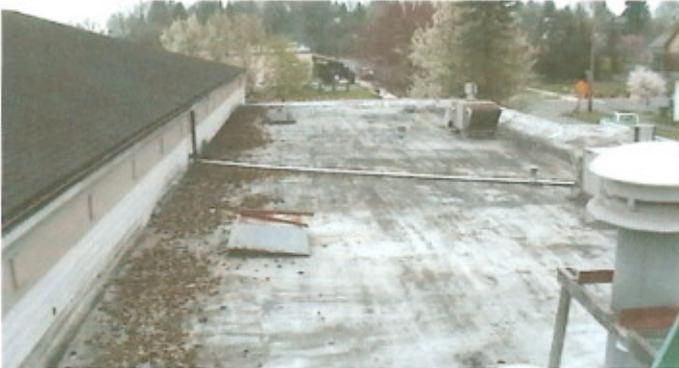
3. Looking West at NW flat roof from north central roof.

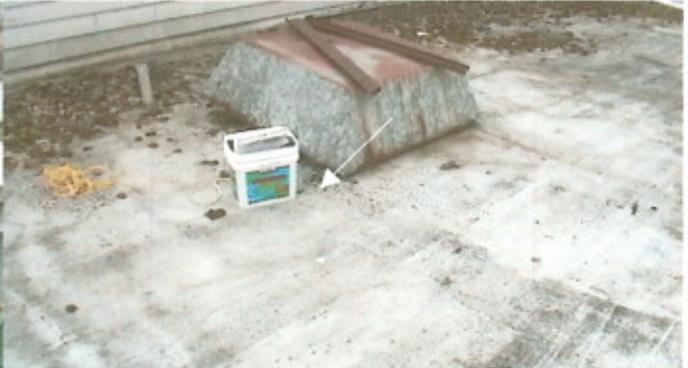
4. Spl: #2: Asbestos Silver Paint on non-asbestos built up.

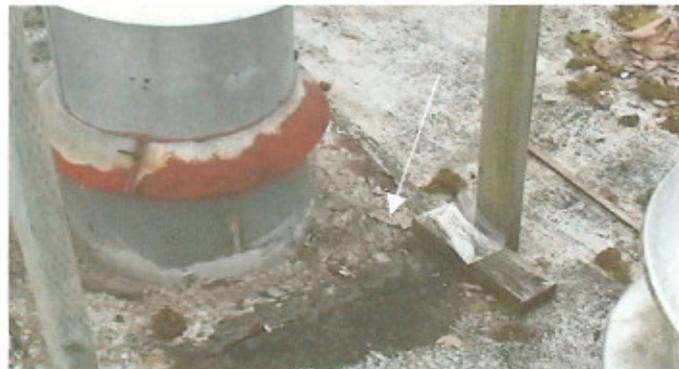
5. Sample #4: Asbestos Silver Paint on roof vent patch.

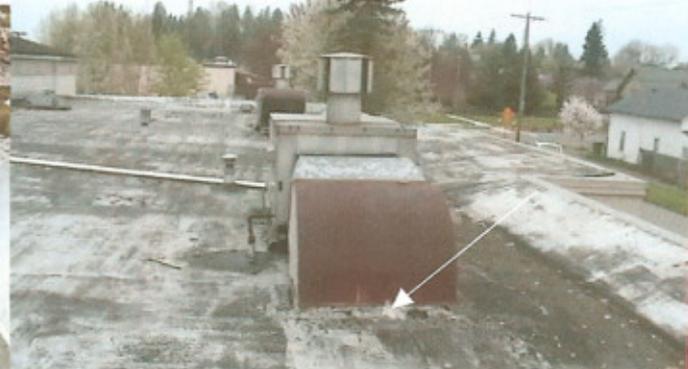
6. NW flat roof, HVAC unit, sample #5 location.

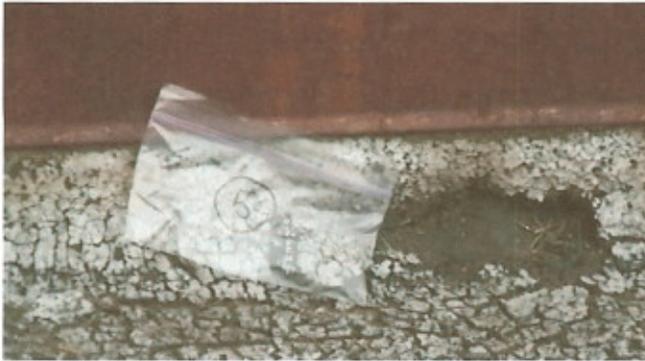
7. Sample #5: Asbestos Silver Paint.

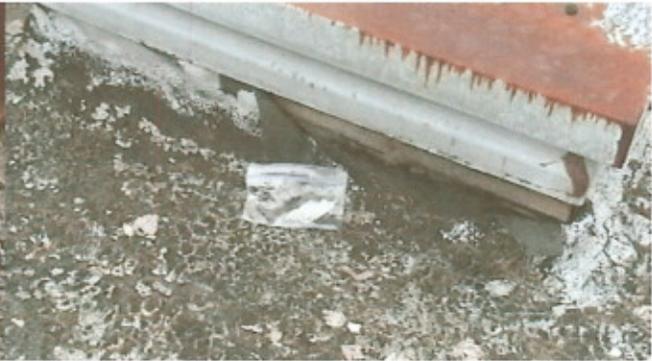
8. Sample #6: Asbestos Silver Paint

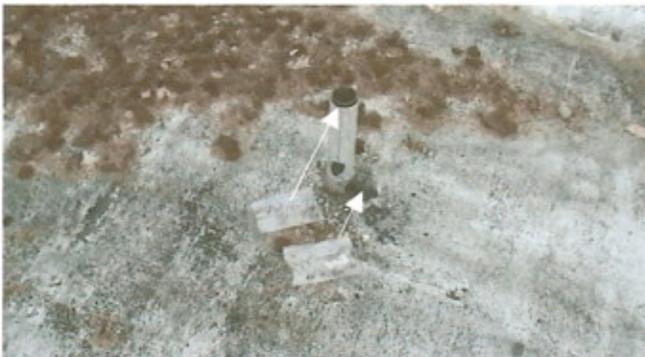
4. **Lead:** Thirteen paint chip sample locations were sampled and none were reported to contain lead. However, since the original Bath House building was built prior to 1978 it could be assumed to contain lead in the paint. EPA lead safe work practices are required for worker protection. Metallic lead, in roofing pipe vent sleeves, was observed and one was sampled (3L) and reported positive for lead.

9. Spl. # 3L: Lead sheath on vent pipe, Spl. #8: Silver Paint

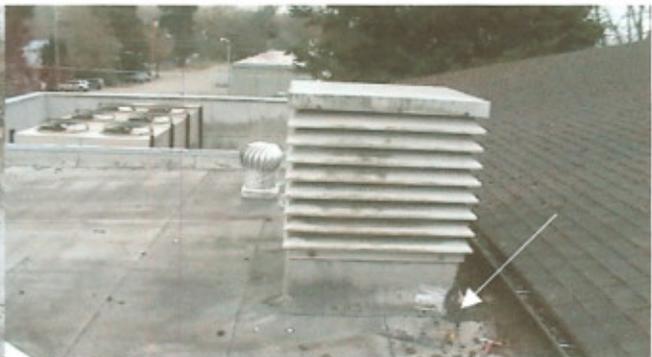
10. North Central flat roof Spl. # 9 location.

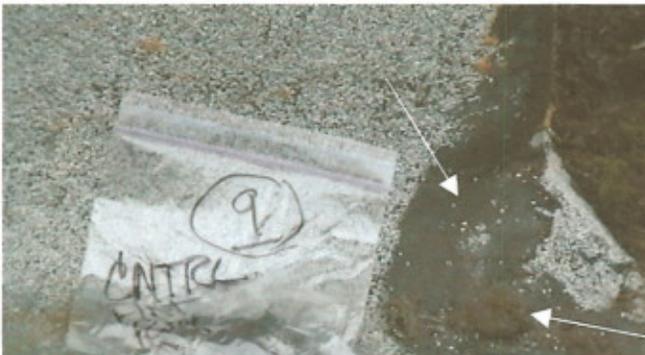
11. Sample # 9: Black asphaltic patch material.

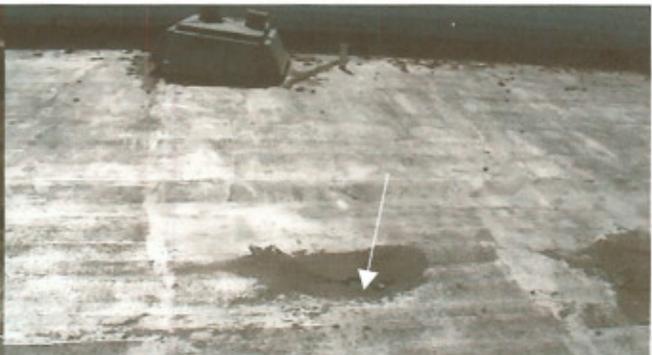
12. Sample # 34: Asbestos Silver Paint under patch.

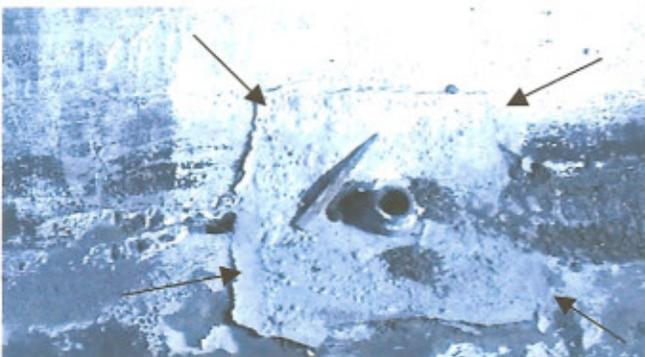
13. Sample # 38: 18" square, drain-patch (3 locations)

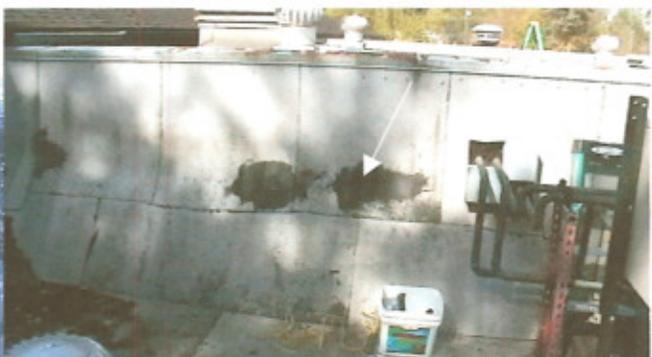
14. Sample # 40. Black asbestos wet patch. Typical
