Snohomish Carnegie Library Snohomish, Washington

A Rehabilitation Master Plan

February 2005

BOLA Architecture + Planning
320 Terry Avenue North
Seattle, Washington 98109

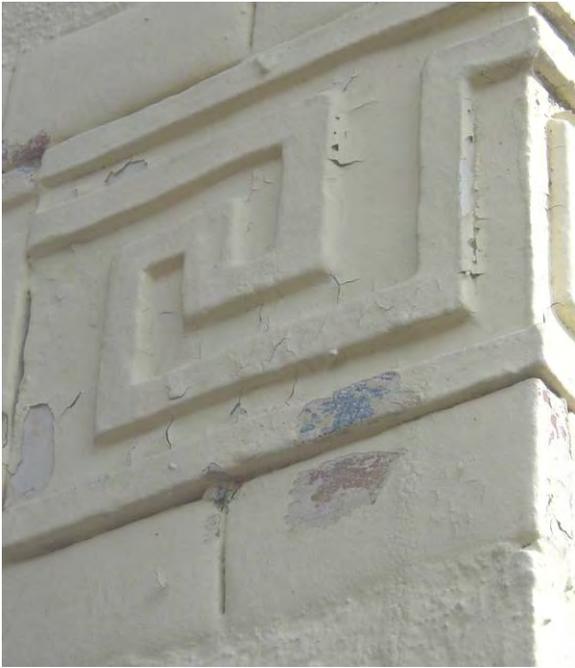
Above, detail of the Greek key banding near the top of the wall. The texture and peeling outer layer of paint suggests that these may be glazed tiles. What may be original colors -- sky blue, brick red and white -- are below the layers of current cream colored paint.

- B. Restore the original Carnegie Library building's exterior walls, window openings, and windows. Restore exterior stucco finish and reconstruct surface decoration where damaged or missing. Clean the entire exterior, patch, prep and repaint stucco and wood surfaces.

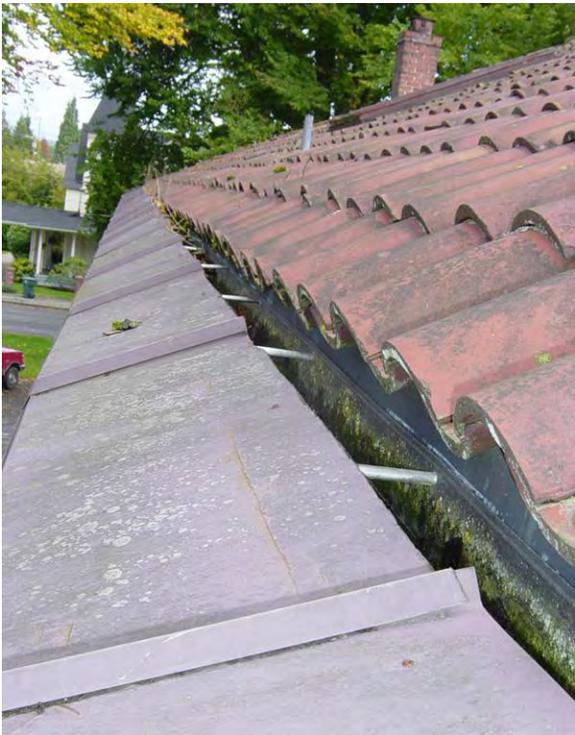
Below, detail of the existing Mission style clay tile roofing and integral sheet metal gutter. Historic photos indicate a different roofing material was used prior to the clay tiles, perhaps as an interim roofing.

- E. Remove, salvage, and securely replace the Mission style clay roof tiles; and provide a new structural plywood diaphragm below the tiles; replace gutters with aluminum gutter to replicate the form of the original wood gutters; replace downspouts with reconstructed original decorative scuppers.

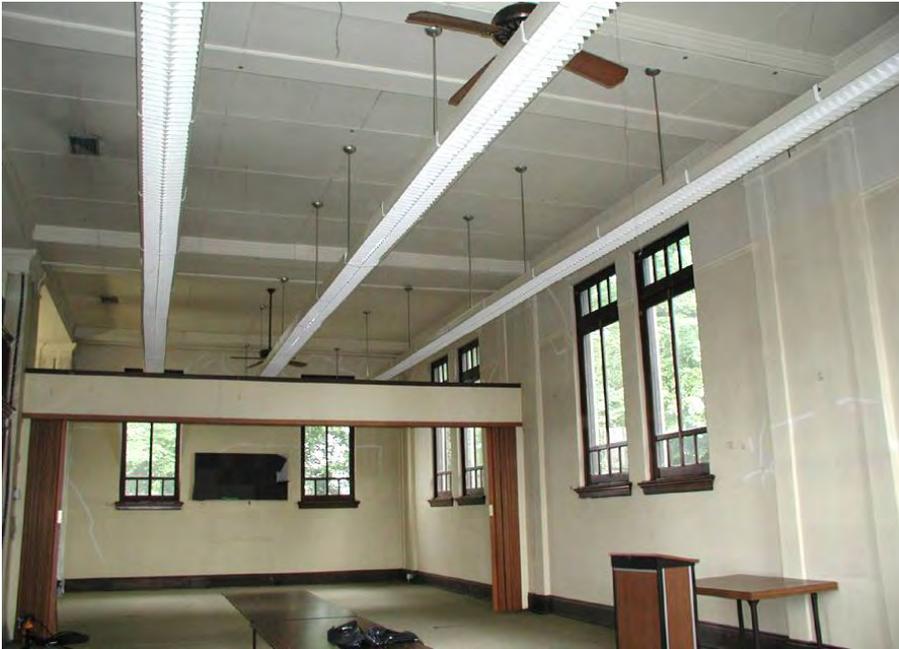
Below, a typical Upper Floor window. These tall, 8'-6" x 3'-9" windows are set with their sills at 5'-4" above the floor. Original library shelving was placed below them at all perimeter walls. The stained wood windows include an awning unit above a large hopper unit, both with multiple true-divided lites.

- F. Repair and restore existing historic windows, and replace in-kind those that are missing. Remove storm windows over operable windows. Provide new insulated glazing at non-operating windows in the Upper Floor Mezzanine. Repair and/or replace roof skylight, and restore interior skylight above the Mezzanine to provide additional interior light.

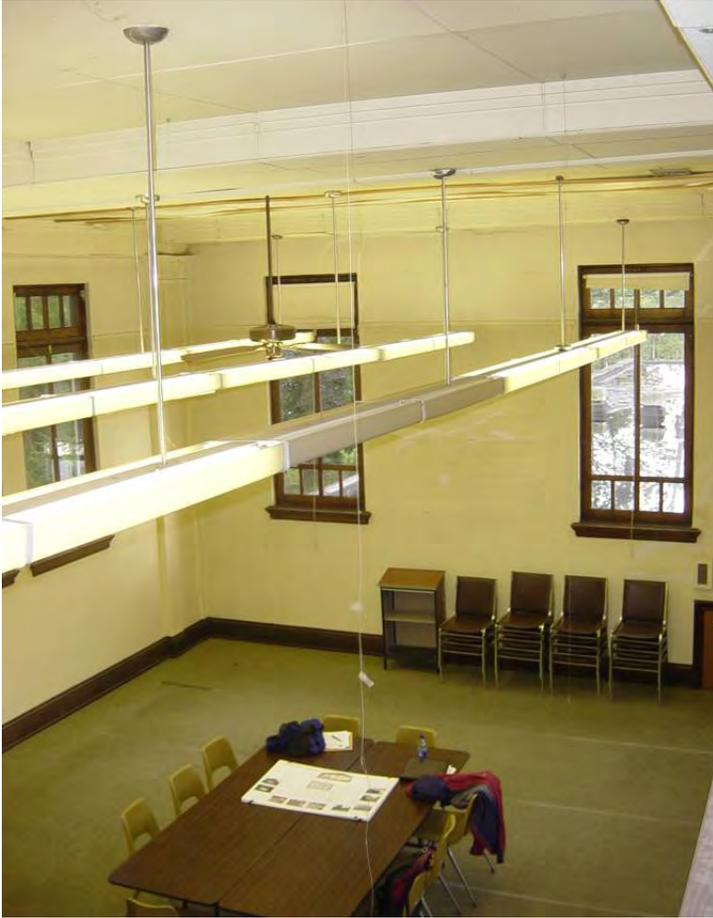
Below, detail showing fiberboard ceiling finish, typical throughout the Upper Floor.

- I. Remove non-original intrusive finishes, such as wood paneling at Basement Meeting Room, and fiberboard sheathing at Upper Floor ceilings, and provide new smooth finish walls and ceiling finishes. Provide furring and insulation at all perimeter walls to enhance energy conservation, finished with new, smooth painted gypsum wallboard. Prep and repaint all interior surfaces, except for stained wood trim, windows, doors and casework.

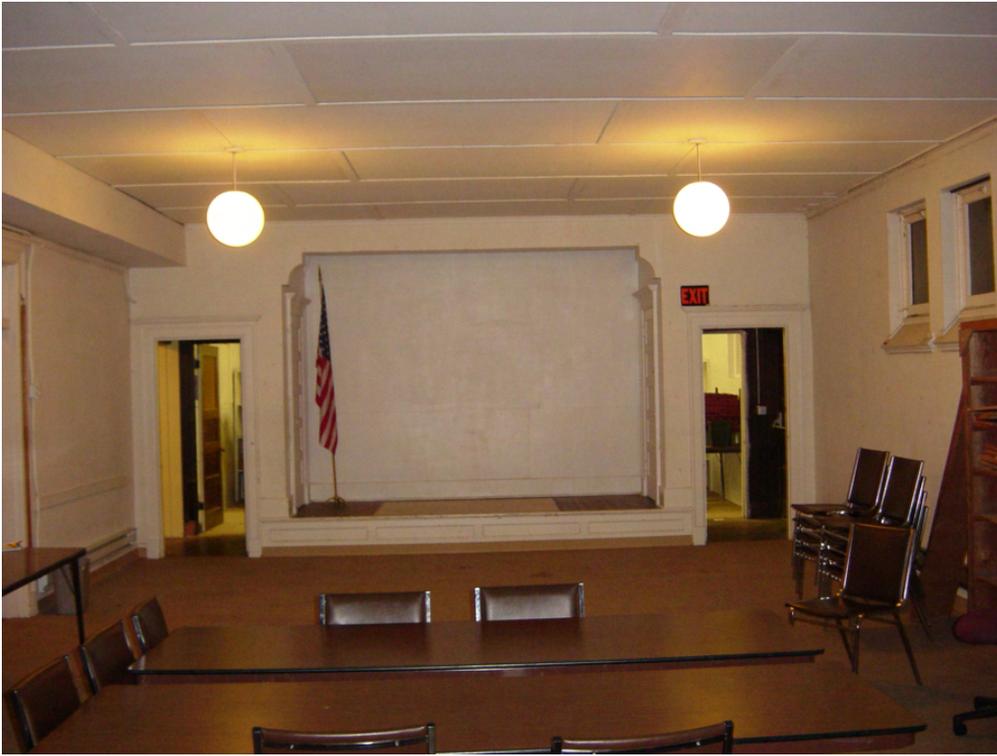
Below, view of the Basement Meeting Room, looking south. The stained plywood paneling covers the concrete foundation walls of the original building, and two original windows at the back of the room. All finishes and fixtures are not original.

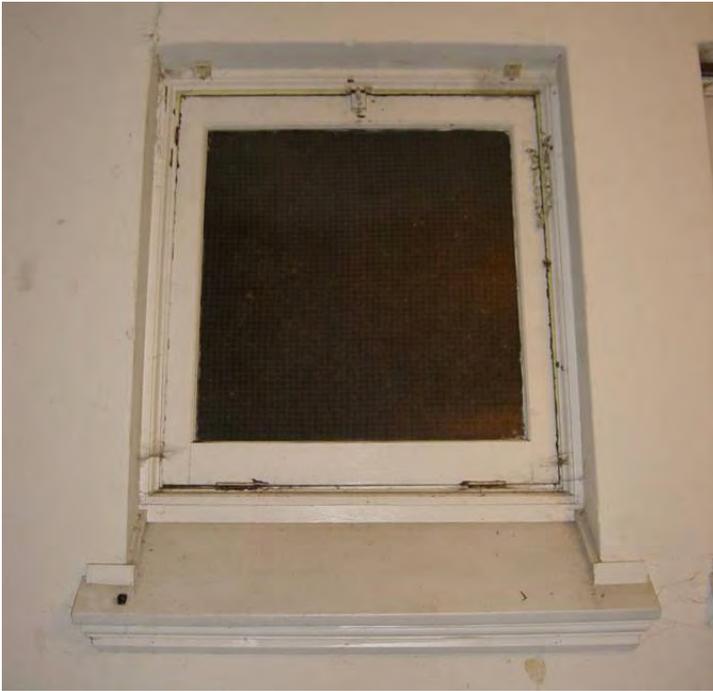
Below, detail of a covered window on the north wall in the storage room at the southwest corner of the Basement. This is one of three similarly covered windows in this space.
