# City of Snohomish

## *Facility Condition Assessment Volume 1: Executive Summary Report*

Prepared by MENG Analysis, December 2023

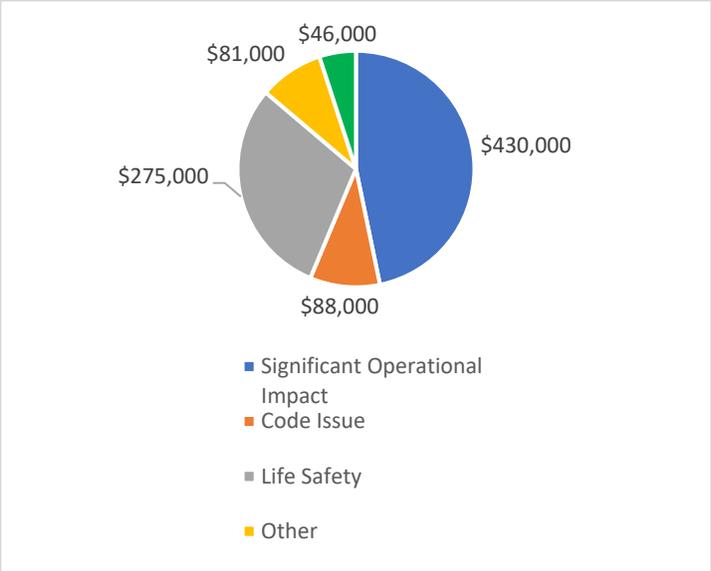
**Figure 1. Deficiencies by Action Type**

For a notable issue to be considered an Observed Deficiency (OD), the surveyor must think that the issue needs to be addressed within the next 5-year period, with an expected direct cost of \$5,000 or greater. Each deficiency is assigned an action type to help prioritize the order in which it should be addressed. The following pie chart shows the ODs broken out by action type.

For the 2023 FCA, ODs total approximately \$37.6M.

Priority ODs are those in the “Life Safety” and “Code Issue” categories, which total approximately \$1.6M. Detailed descriptions, photos, and cost estimates of these deficiencies can be found in the Facility Details Report (Volume 2).

As is shown in **Figure 1**, most of the City's deficiencies fall within the Significant Operational Impact category. Items in this category range from heating and cooling systems at the Boys and Girls club to door and door hardware at several park facilities. The largest contributor relates to the relocation the public works shop's site to an area that is not at risk of flooding.

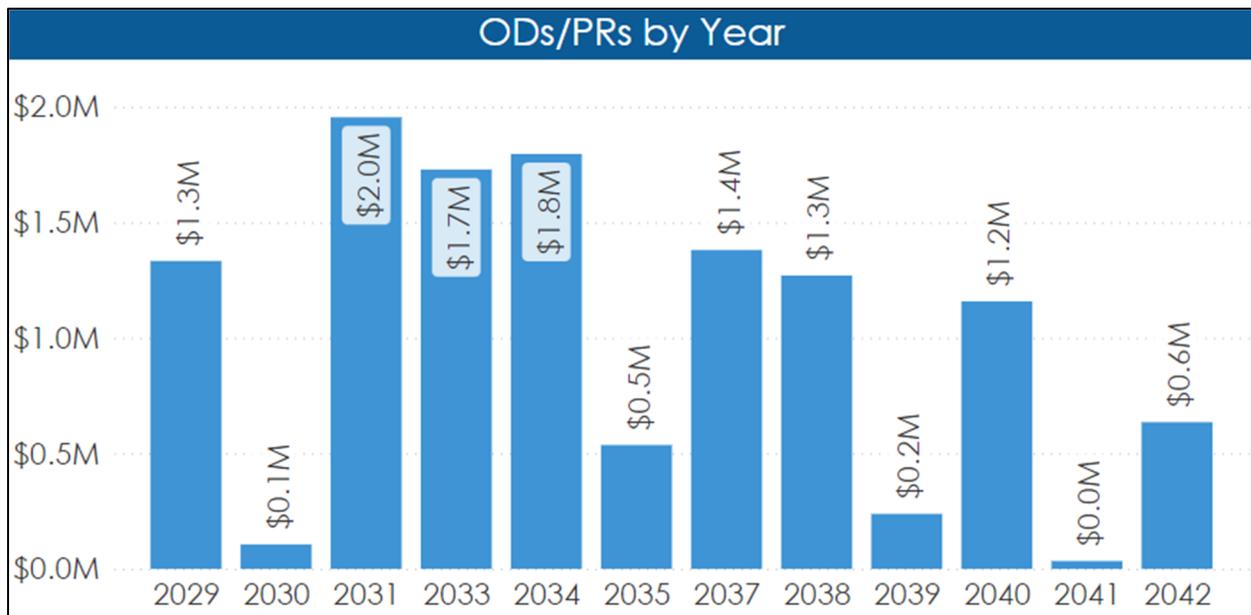
**Figure 2. Predicted Renewal Totals by Year**

Predicted Renewals (PRs) are modeled for the years 2029 – 2042, based on the system type, age, current condition, expected useful life, and anticipated replacement cost. These costs are based on predictive models, and therefore should be used as a high-level, long-term planning tool. Some systems may fail sooner or last longer than the model predicts based on maintenance practices, intensity of use, or extreme weather events.

For the time period of 2029 – 2042, the estimated PR cost is approximately \$12M. The highest cost year is expected to be 2031 at just under \$2M. The detailed PR table included in the Appendix shows these PRs broken out by facility, subsystem, and year. Years omitted from the chart below have no predicted renewals occurring in that year.
