Snohomish Carnegie Library Snohomish, Washington

A Rehabilitation Master Plan

February 2005

BOLA Architecture + Planning
320 Terry Avenue North
Seattle, Washington 98109

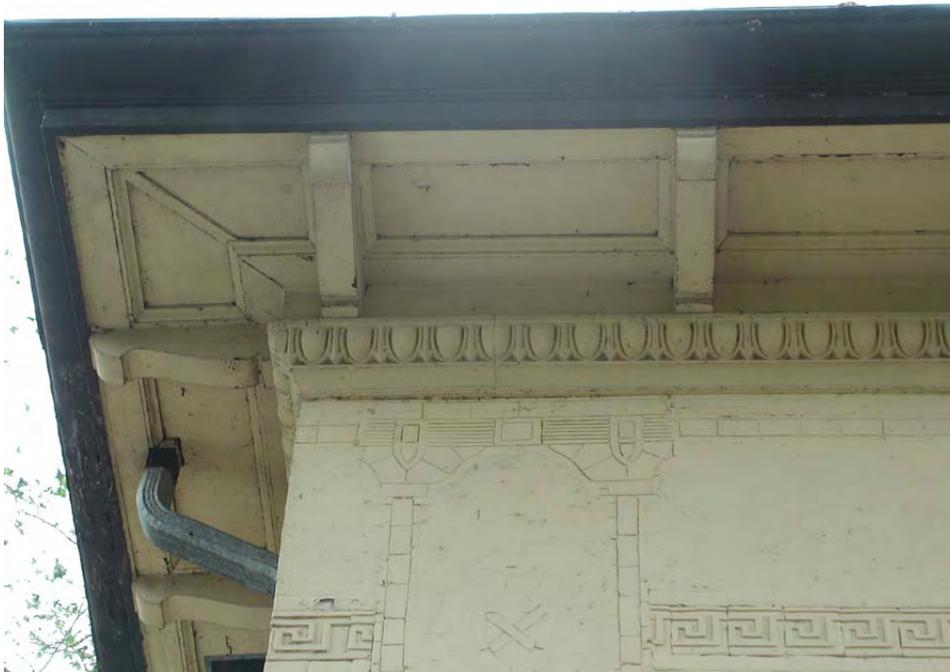
Above, detail of the Greek key banding near the top of the wall. The texture and peeling outer layer of paint suggests that these may be glazed tiles. What may be original colors -- sky blue, brick red and white -- are below the layers of current cream colored paint.

- B. Restore the original Carnegie Library building's exterior walls, window openings, and windows. Restore exterior stucco finish and reconstruct surface decoration where damaged or missing. Clean the entire exterior, patch, prep and repaint stucco and wood surfaces.

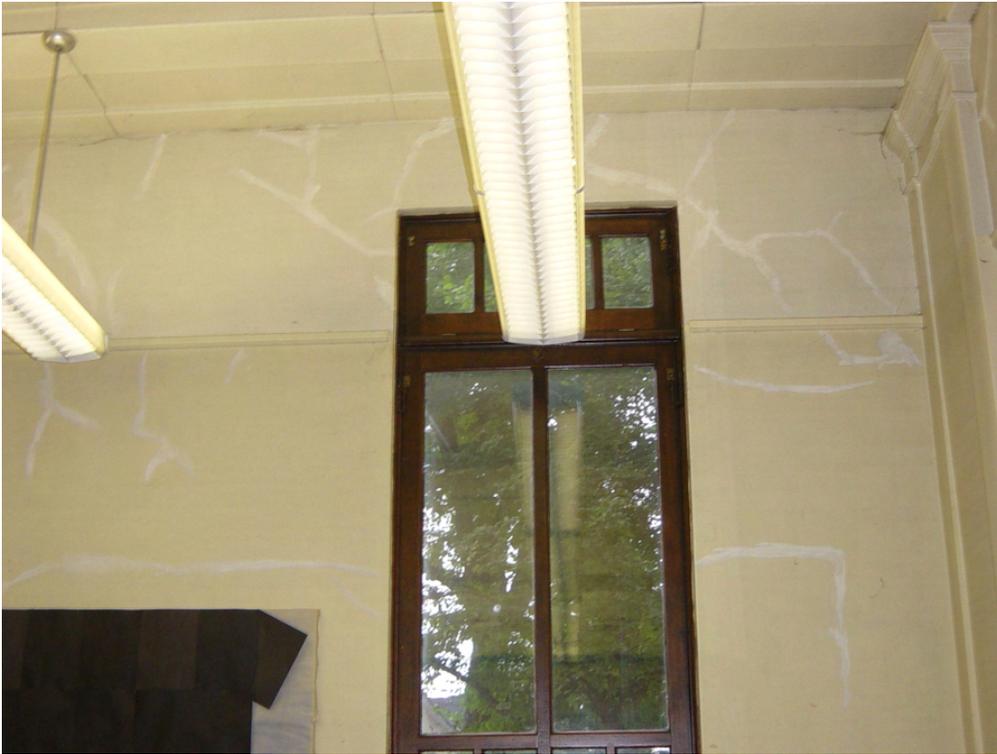
Above, view of the north wall of the Upper Floor, showing plaster cracking and repair efforts, which are typical throughout the space.

- I. Remove non-original intrusive finishes, such as wood paneling at Basement Meeting Room, and fiberboard sheathing at Upper Floor ceilings, and provide new smooth finish walls and ceiling finishes. Provide furring and insulation at all perimeter walls to enhance energy conservation, finished with new, smooth painted gypsum wallboard. Prep and repaint all interior surfaces, except for stained wood trim, windows, doors and casework.

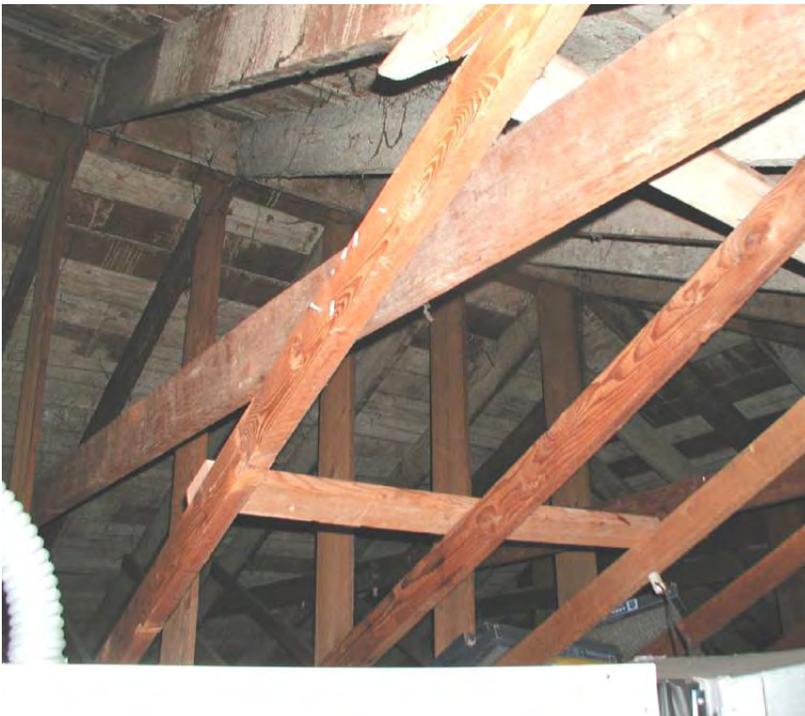
Above, view of the roof truss and ceiling joist construction at an exterior wall. Source: Degenkolb Engineers.

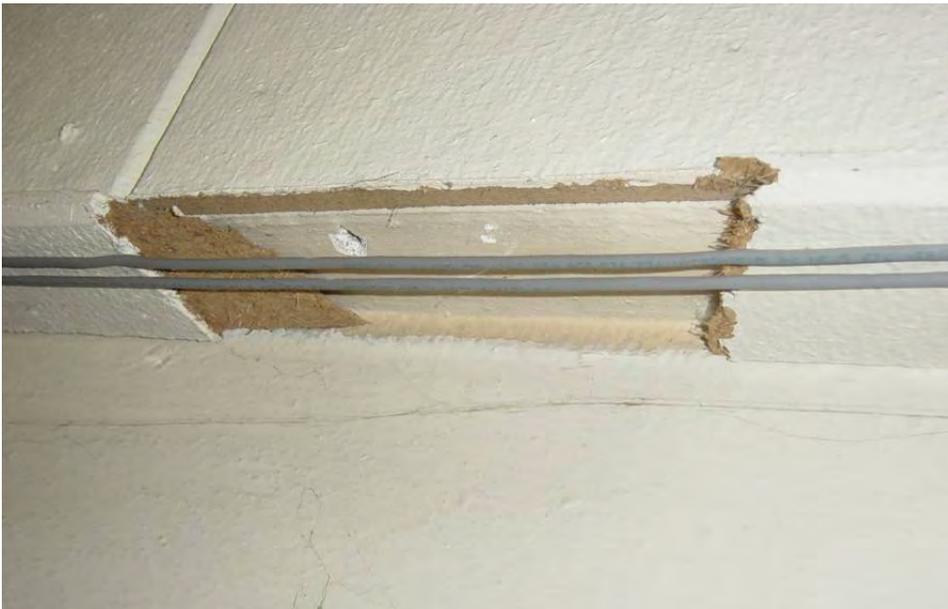
Below, detail showing fiberboard ceiling finish, typical throughout the Upper Floor.

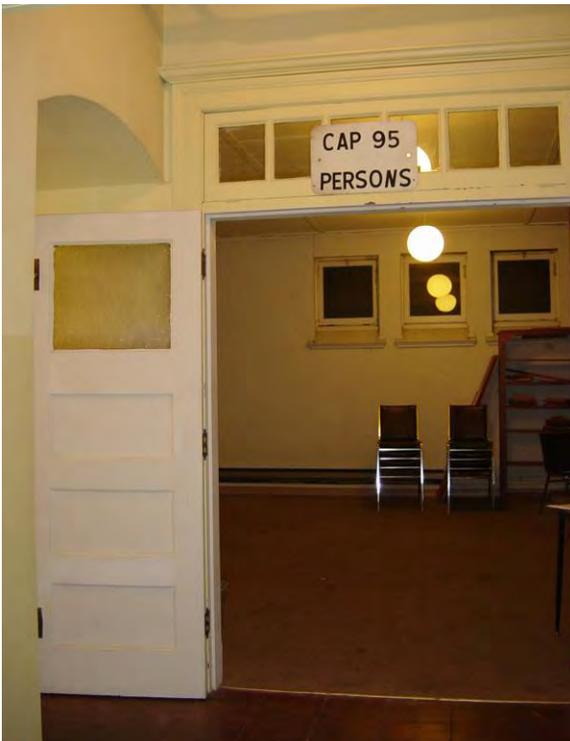
Above, view of a Hall in the original building Basement, looking south. Note the vaulted ceiling and the panel doors. The Hall leads past the Men's Restroom to a storage space at the southwest corner.

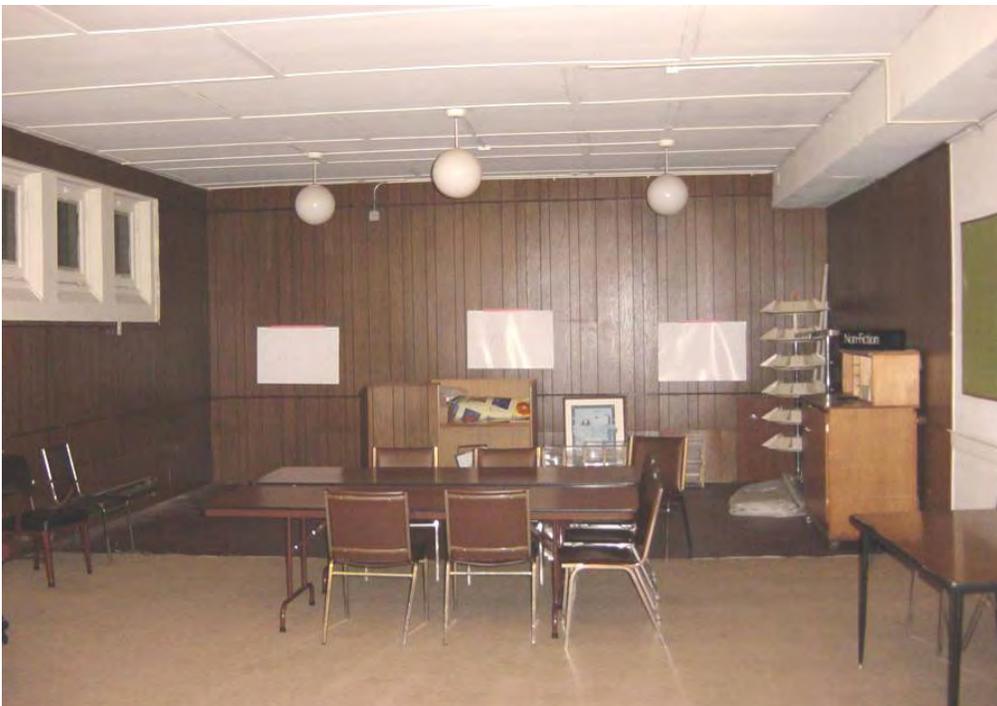
Above, view of the Basement Meeting Room, looking north towards the small raised stage.

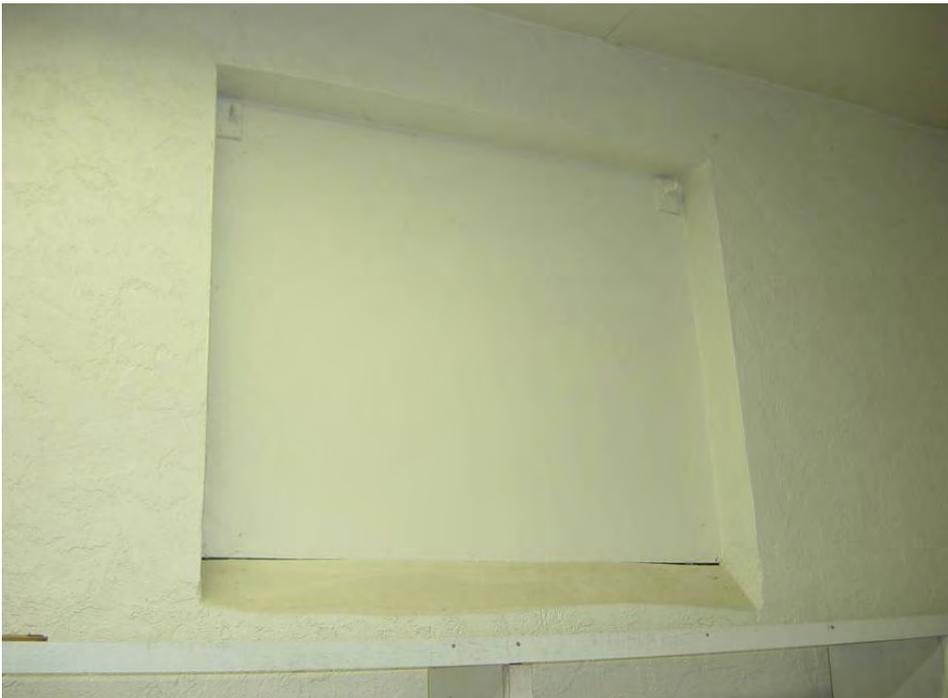
Above, detail of a typical Basement window with sloped sill and single, wood hopper sash unit.

- F. Repair and restore existing historic windows, and replace in-kind those that are missing. Remove storm windows over operable windows. Provide new insulated glazing at non-operating windows in the Upper Floor Mezzanine. Repair and/or replace roof skylight, and restore interior skylight above the Mezzanine to provide additional interior light.
